PROGRESS REPORT II

Kunde Hospital Rebuild (Main Block – no. 2)

Prepared and Submitted By:
Yangji Doma Sherpa
Project Coordinator (Nepal)
The Sir Edmund Hillary Foundation – Canada

Date: 15 August 2016

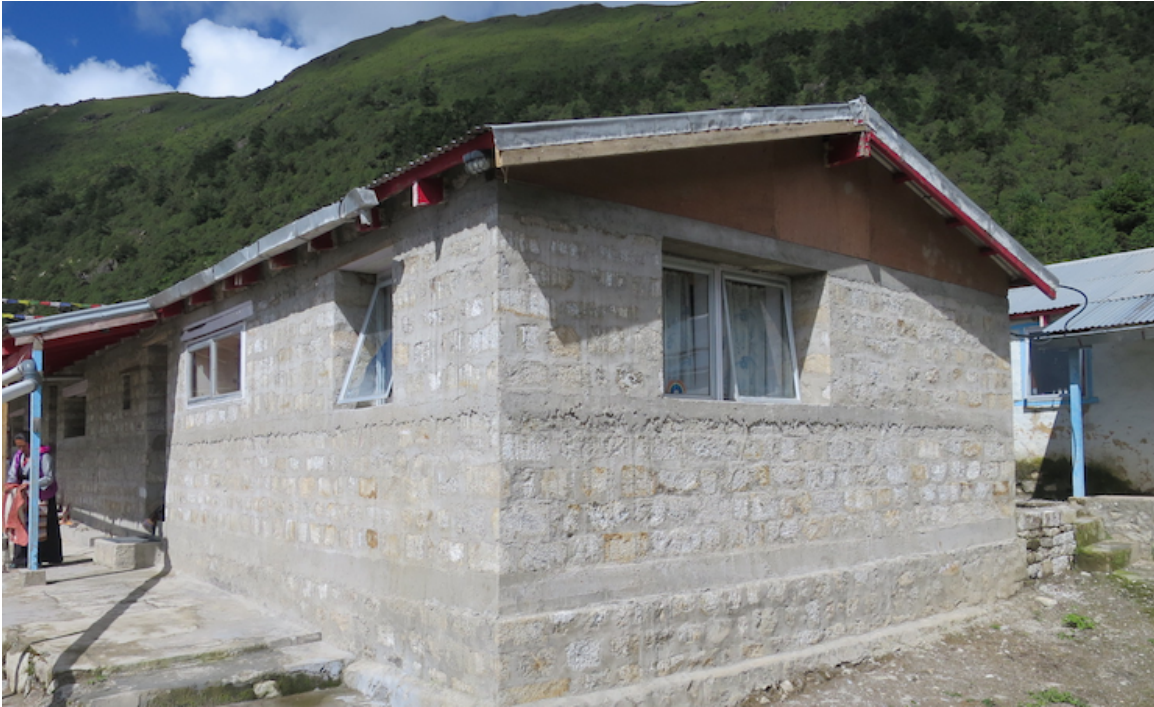
Figure 1: Completion of reconstruction of outer stone masonry wall of the main block (no.2)

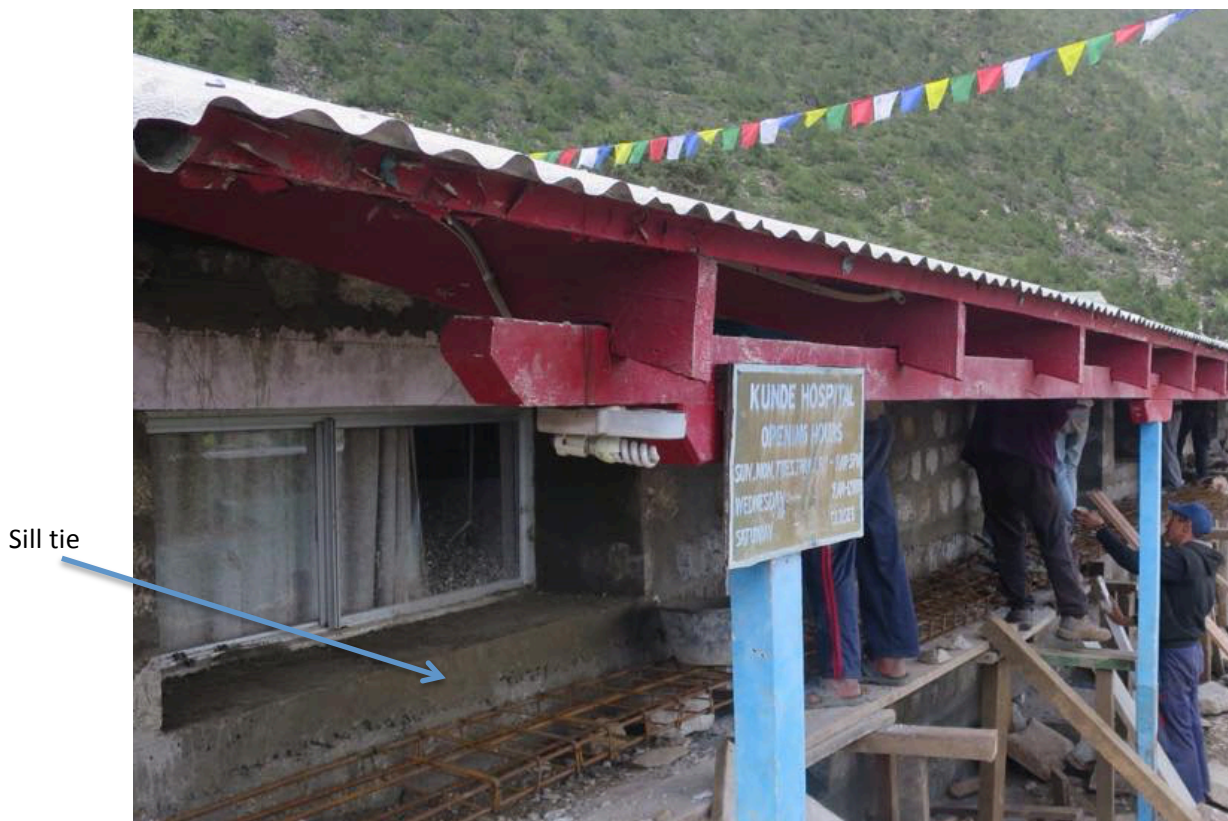
1. Sill tie below window level

Figure 2: A sill tie made out of iron rod and cement mortar has been placed below the window level to bind the construction materials together to make it earthquake resistant

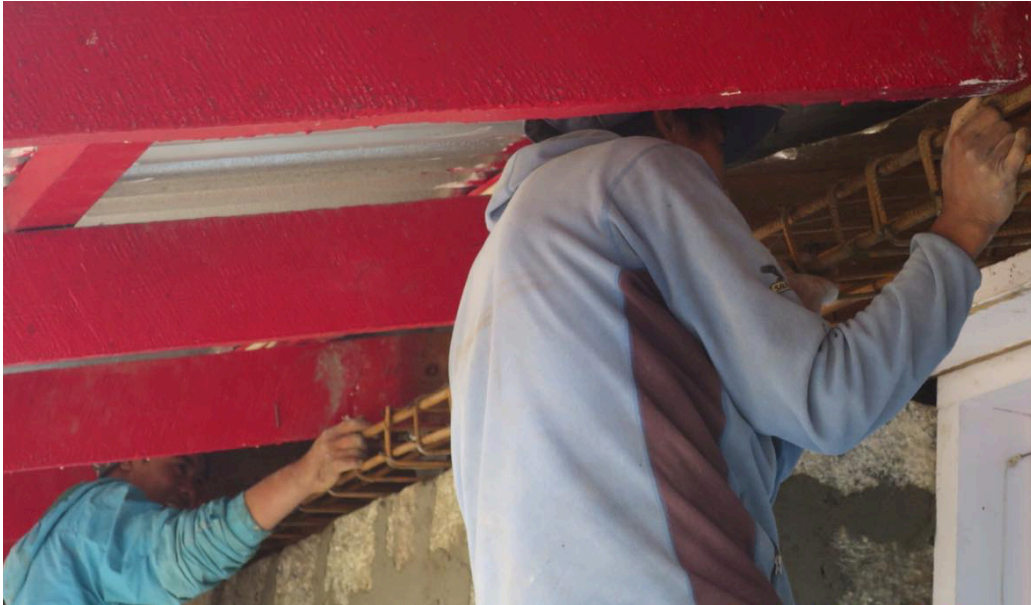
2. Lentil tie above the level of doors and windows

Figure 3: A lentil tie made out of iron rod and cement mortar has been placed above doors and windows level to make the masonry wall more stable

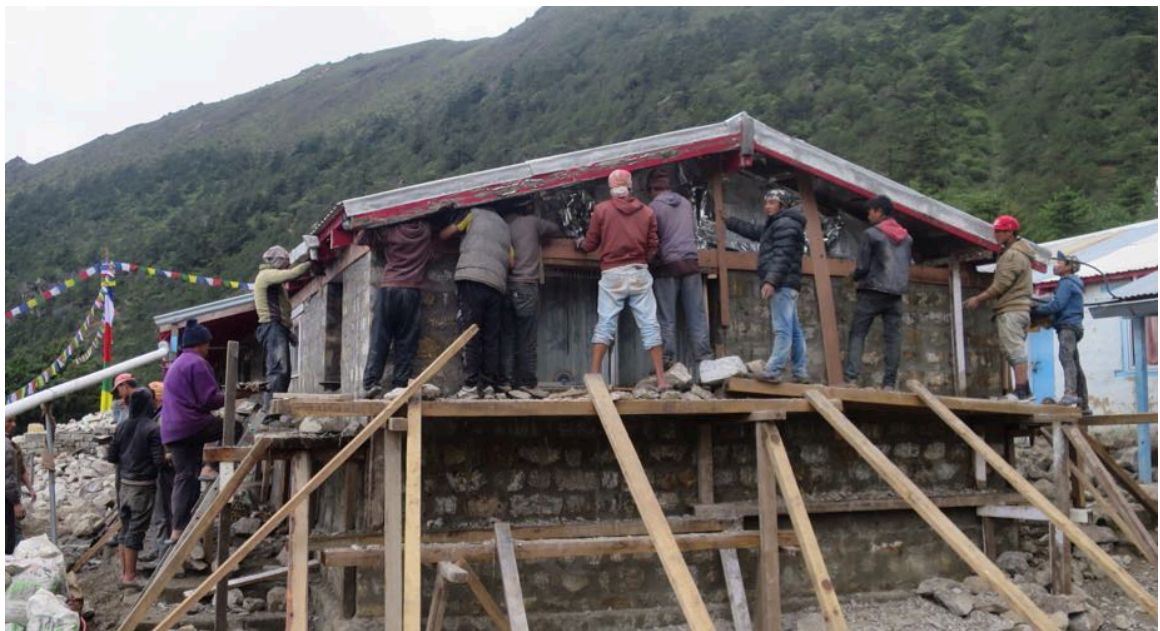
Figure 4: Builders setting up lentil tie around the main building

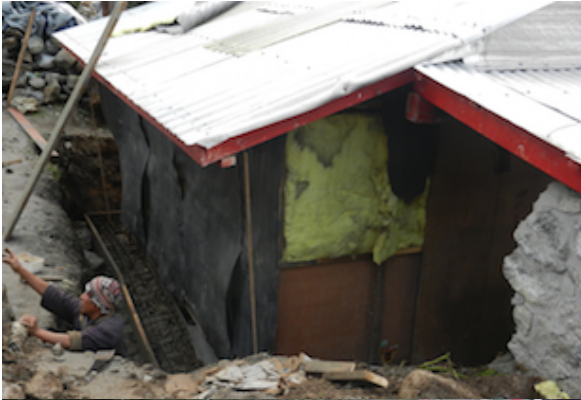
3. Extension and reconstruction of X-ray/ultrasound/drug store room at the back of the building

Figure 5: The drug store/X-ray/ultrasound room at the back of the building has been extended and reconstructed

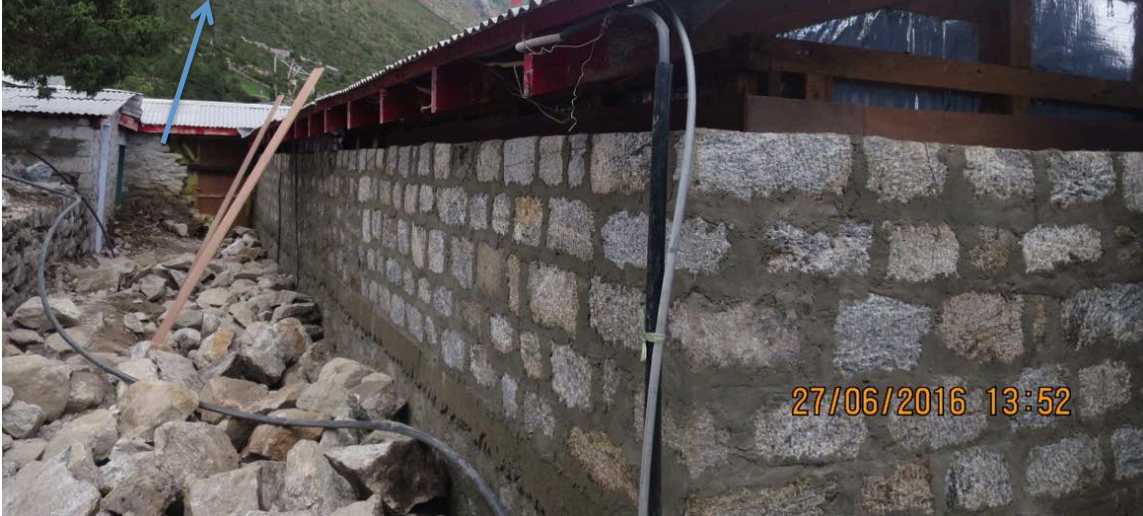
Figure 6: Back view of the reconstruction of stone masonry wall of the main building along with the attached drug store/X-ray/ultrasound room

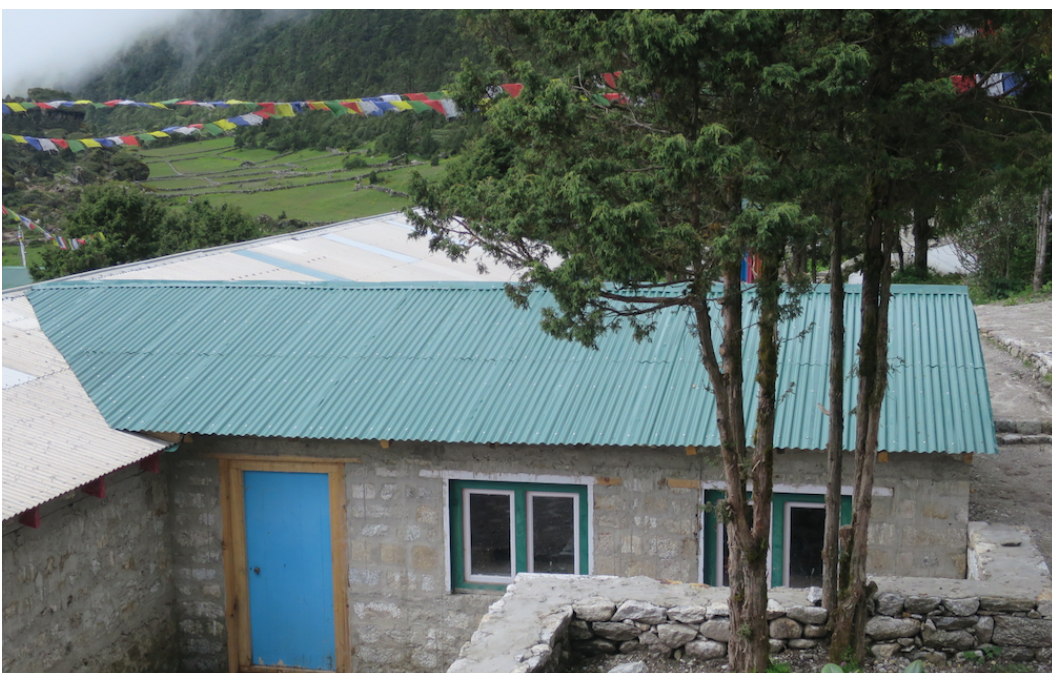
Figure 7: Completion of reconstruction of drug store/X-ray/ultrasound room

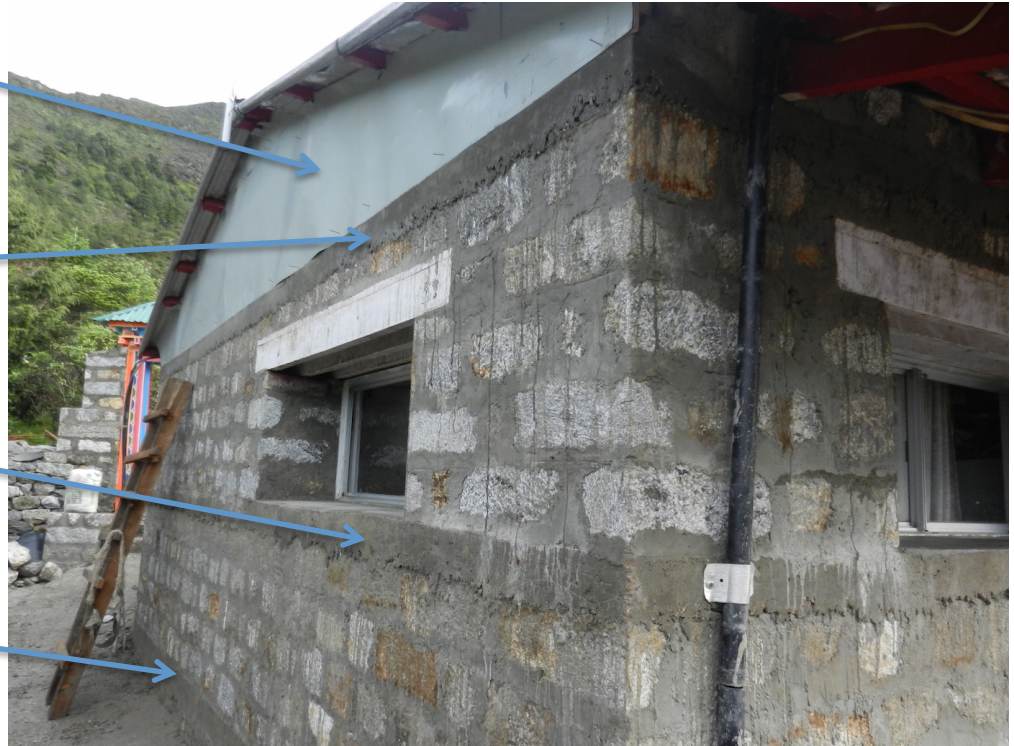
4. Completion of outer stone masonry wall adopting earthquake resistant construction methods

Plywood, insulation and plain sheet are used in the gable instead of stones

Lentil tie above the level of doors and windows

Sill tie placed below the window level

DPC layer above ground level

Figure 3: A three-layer tie beam (DPC, Sill and Lentil) has been incorporated in the newly reconstructed stone masonry wall to make it earthquake resistant. Further, vertical rods of 16 mm diameter have been placed at a distance of 8 feet throughout the building.

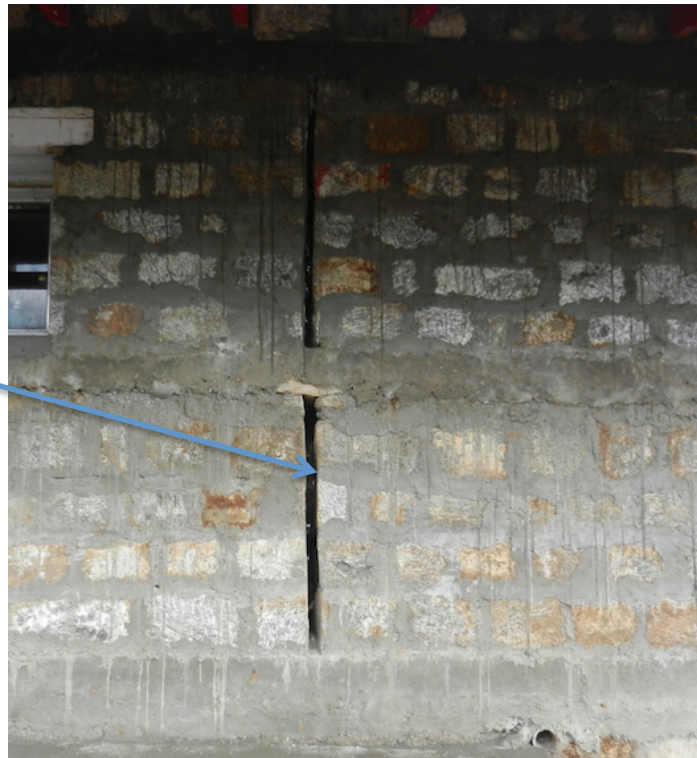
Expansion gap

Figure 4: An expansion gap of 2" has been made in the wall at a gap of 12 feet excluding in areas where there are doors. The expansion gap will help in releasing pressure during movements of the building.
